**UTTARAKHAND ELECTRICITY REGULATORY COMMISSION**

Electrocution of Sh. Bhagwant Lal S/o Shri Prem Ram residence of village- Aholi Sunar (Syali), P.O.- Syalidhar, Distt.- Almora on 13-14.08.2008 at 02:00 Hrs.

**Date of Order: 22<sup>nd</sup> September 2009**

**ORDER**

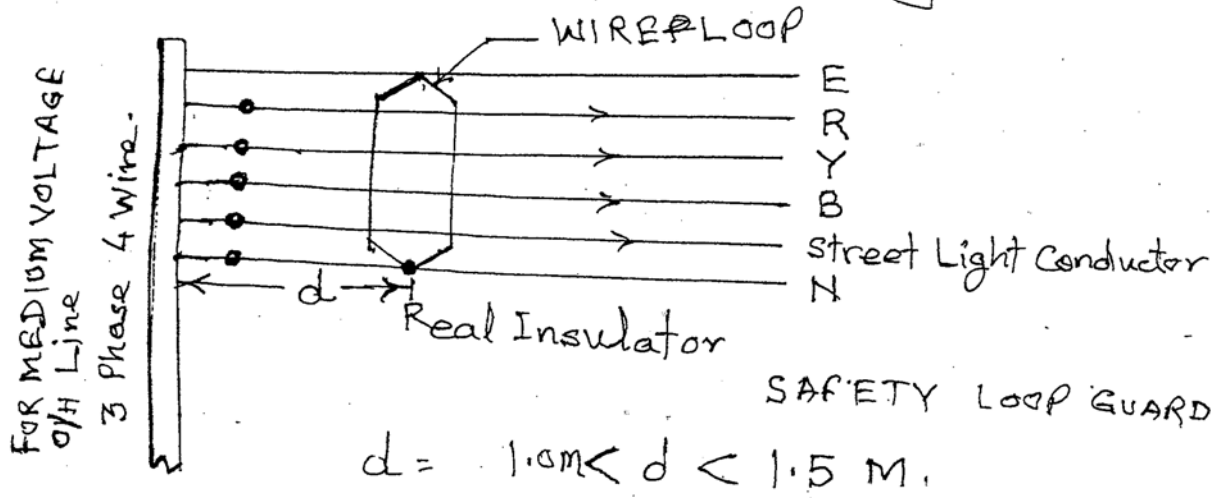
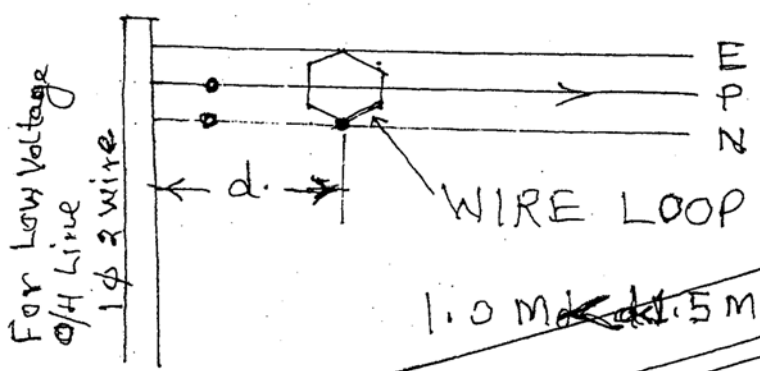
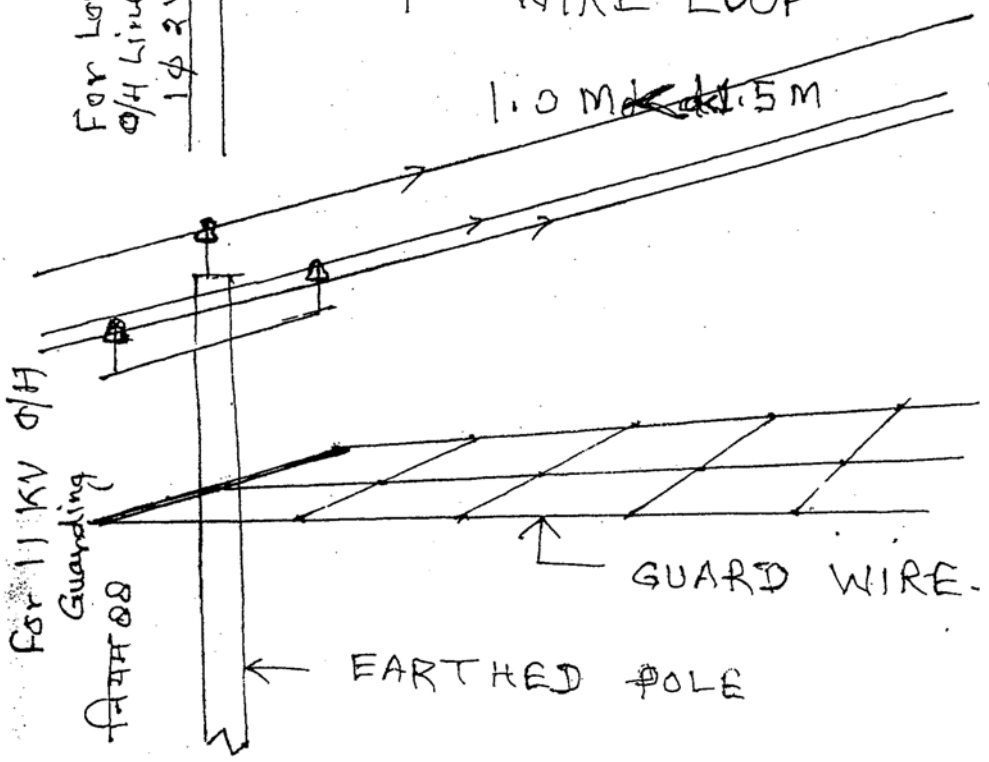
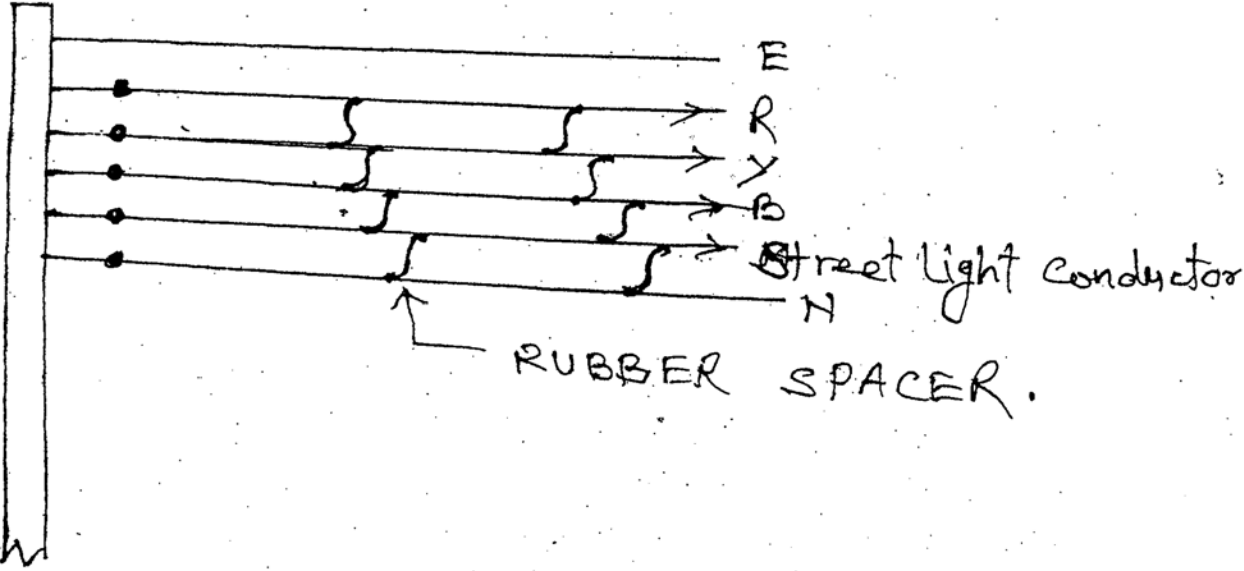
नियम 91(1) के अन्तर्गत गाड़िंग अन्वय युक्तियां

- 2- एल०टी० एवं मीडियम वोल्टेज ओवर हेड लाइन में सेप्टी लूप गार्ड की व्यवस्था पोल के दोनो ओर " 1 मीटर से 1.5 मीटर की दूरी पर इस प्रकार की जायेगी कि सजीव तार टूटने की स्थिति में जमीन पर गिरने से पूर्व निर्जीव हो जाये। ड्राईंग संलग्न है तथा एल०टी० ओवर हेड लाईनों में उक्त युक्ति हेतु स्पेशर की व्यवस्था भी कराई जा सकती है।
